**AVIATION INVESTIGATION REPORT
A01A0030**

MULTIPLE ENGINE FLAME-OUTS

**AIR CANADA REGIONAL AIRLINES
DE HAVILLAND DHC-8-100 C-GANS
SYDNEY, NOVA SCOTIA
03 APRIL 2001**

Report Number A01A0030

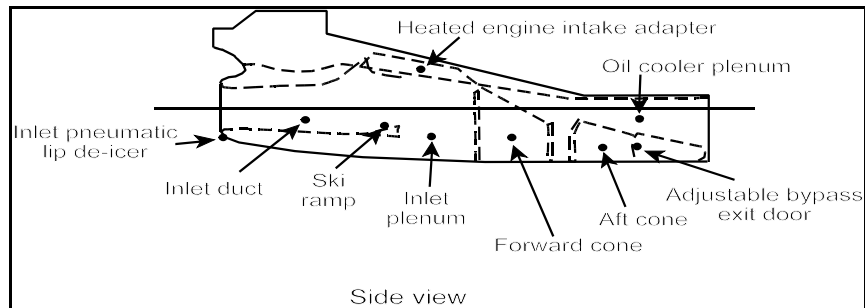
Figure 1. DHC-8 Engine nacelle

The first officer completed the pre-flight inspection at 1500. This included a tactile inspection of the engine plenum areas through each by-pass door; no contamination was found. A visual inspection of the engine air inlet ducts was conducted from the ground. However, the lower portion of the inlet ducts would not be visible from this vantage point.

Immediately after the pre-flight inspection, the ground handler installed the engine air intake plugs to prevent snow from accumulating inside the engine air inlets. He gained access to the air inlets by standing on the baggage cart and examined the air inlet ducts visually and by running his hand inside them before installing the plugs and again after they were removed (at 1520) for the start of the right engine to warm the aircraft cabin prior to passenger boarding. The ground handler did not see or feel any contamination during the installation and removal of the inlet plugs. The flight crew carried out visual inspections of the engine air inlets from the cockpit during the de-icing operation, prior to engine start, and just prior to the start of the take-off roll and no contamination was observed.
